KIT ID: 03-F3-111-4477

Project Name:Jane's HouseSampling Date:January 15, 2024Analysis Date:January 30, 2024

One Main Street, Princeton, NJ 08540

ANALYSIS SUMMARY

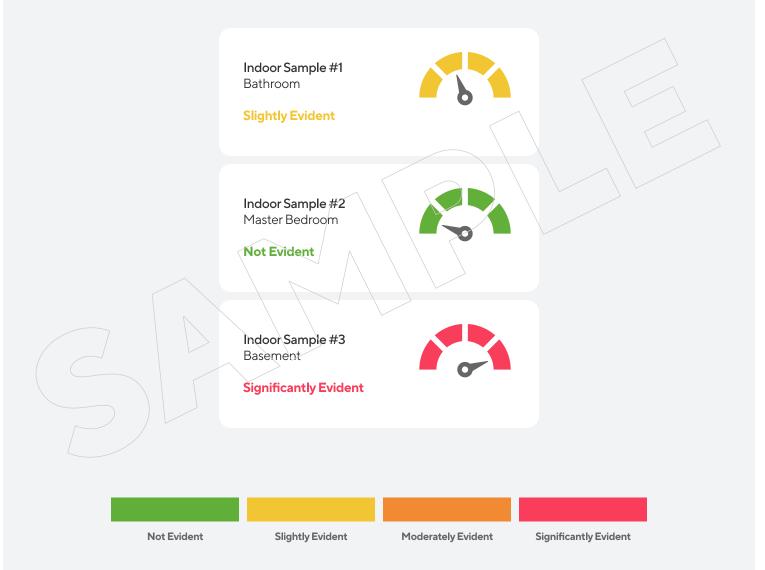
The results of your mold test are included below. Listed under each sample number is the location from which the sample was taken and an indicator that specifies the severity of the result for that given sample. More detailed data on each sample can be found at the end of this report.

Evidence of indoor mold growth was detected in the samples you submitted described as Bathroom and Basement.

No abnormal spore counts were detected in the sample you submitted described as Master Bedroom.

A mold problem is a moisture problem. The first and most important step is always diagnosing and correcting the underlying cause of dampness. Do you know where it's coming from and what needs to be done? If not, a good place to get started is our nonnesense, 45-page ebook, How to Find Mold. It's filled with professional tips and techniques, inspection checklists, a selection of FAQ's, and other valuable resources. And the best part is that it's free!
